Manhole Inspection Summary

Manhole # S21G__054MH

Insp Date: **10/9/07 1:29 PM**

Location Address: **1900 FAYETTE-VINE**

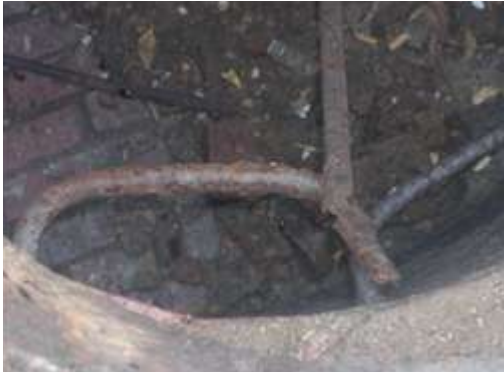
Defect 3

Steps Count: **2** Missing: **0** ☒ **Corroded**

CORRODED STEP

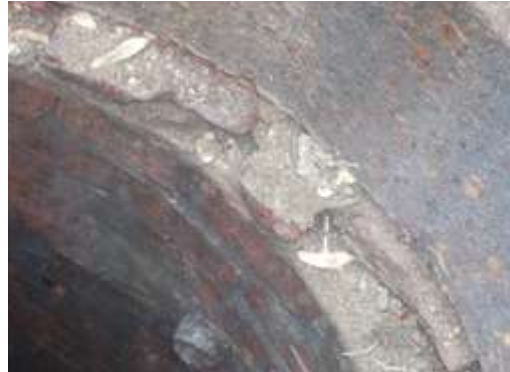
Defect 2

Chimney / Frame Adjustment ☒ Exists Material: **Brick** ☐ Parged Height: **3** (in.)

Condition: ☐ Sound ☐ Cracked ☐ Root Intrusion ☐ Loose Brick ☒ **Deteriorated**

DETERIORATED CHIMNEY

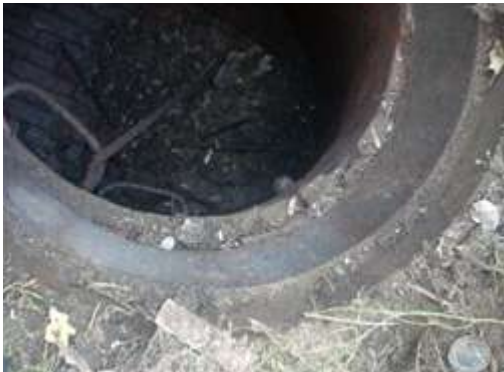
Defect 1

Frame Offset: **1** (in.) Condition: ☒ Sound ☐ Cracked ☐ Leaks

FRAME OFFSET

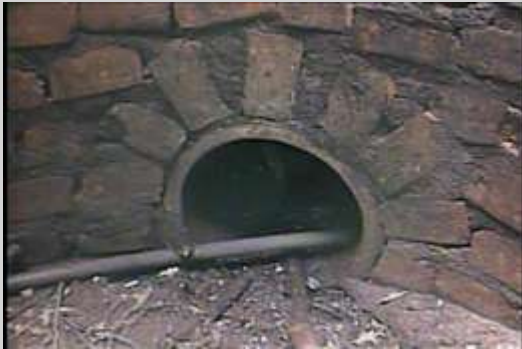
12 O'Clock Outflow

8 in. Circular Gravity Sewer
Pipe Out @ 12 O'Clock

Deposits: ☐ None ☐ Mud ☐ Sludge ☒ **Debris** ☐ Grease

Silt Depth: **1** (in.) Deposits Extent: **Light**
